Debris/Ice/TPS Assessment And Integrated Photographic Analysis For Shuttle Mission STS-49

July 1992

Gregory N. Katnik
NASA/Kennedy Space Center

OV-105 Endeavour (1st flight), ET-43 (LWT 36), BI-050 SRBs

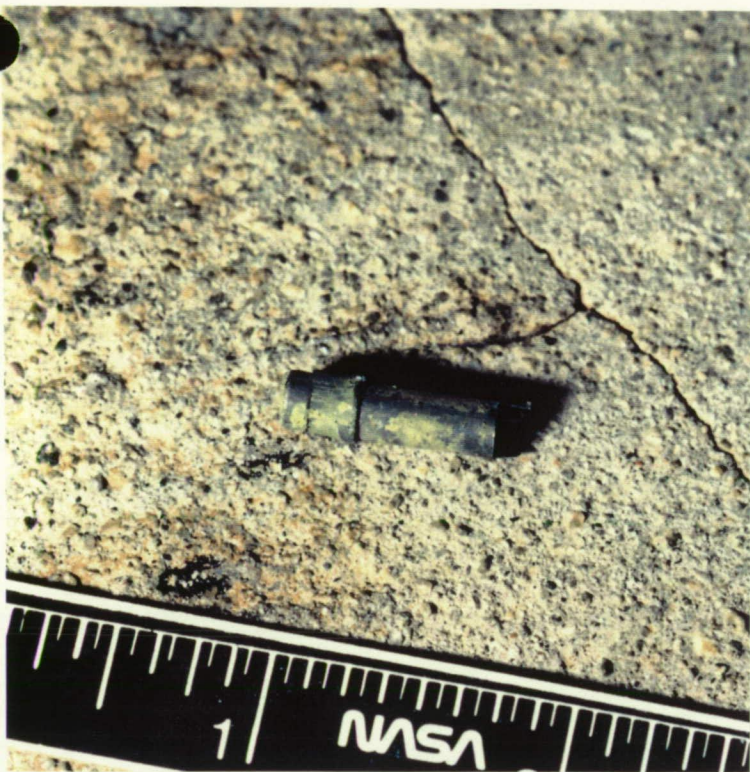
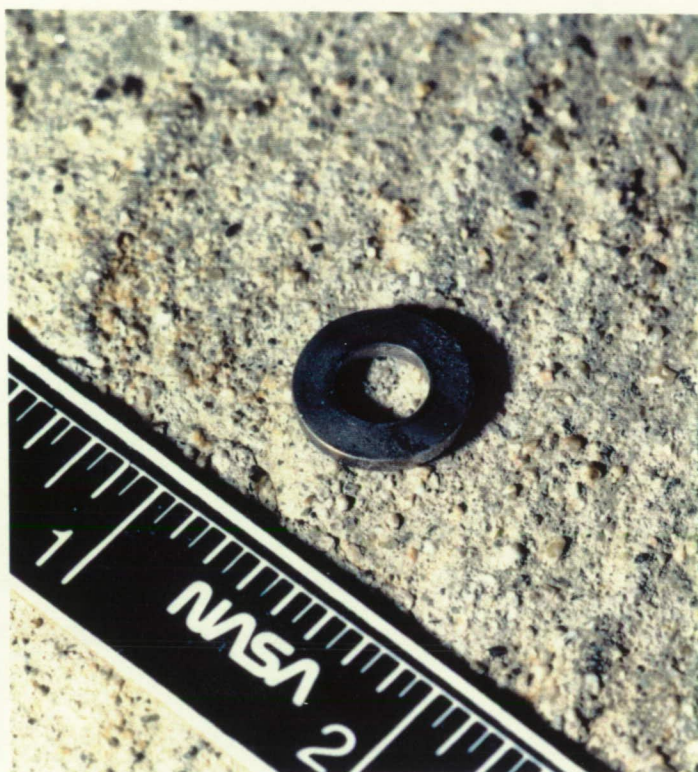
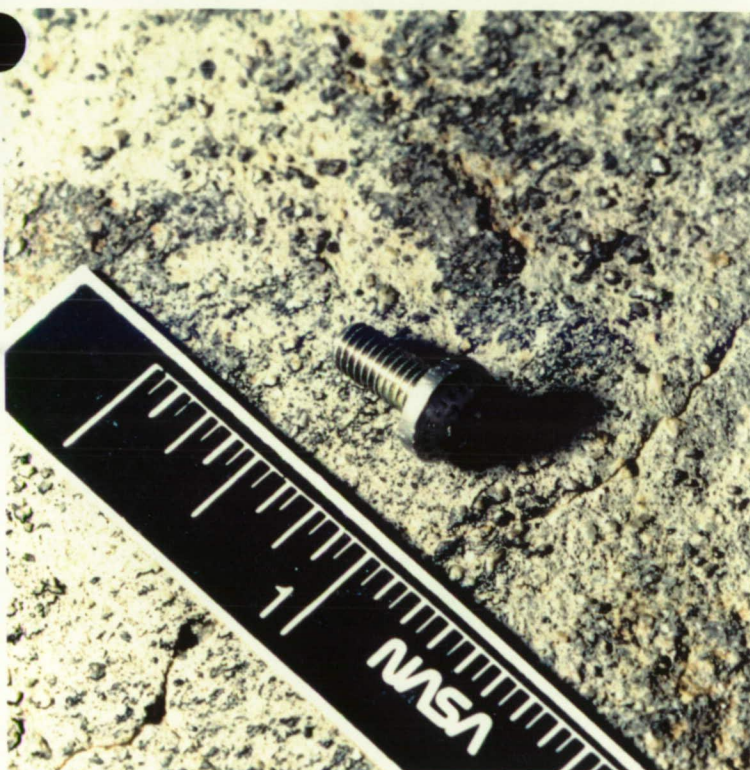
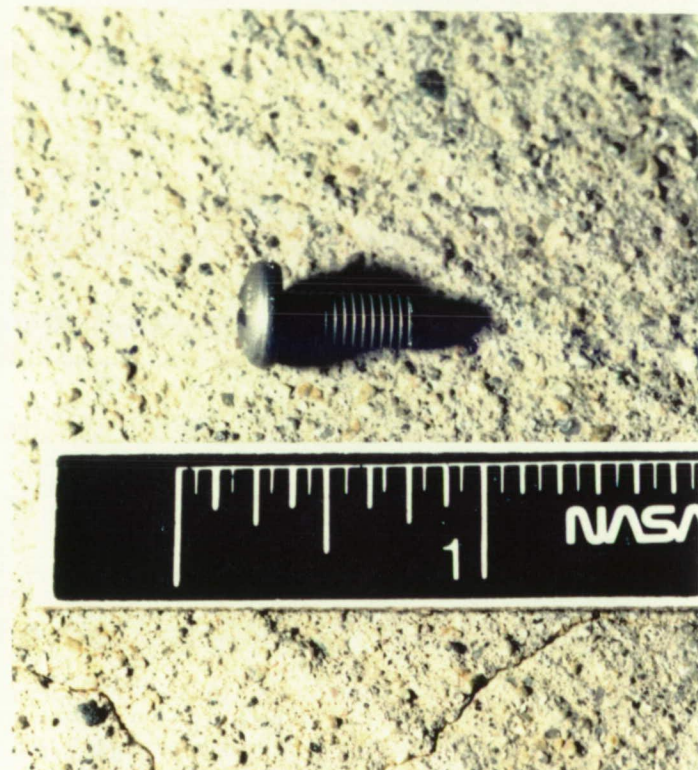
A segment of a Jo-bolt, a spacer (washer), and a Torx head screw were found on the runway under the RH ET/ORB umbilical door. A second Torx head screw lay on the runway under the LH ET door.

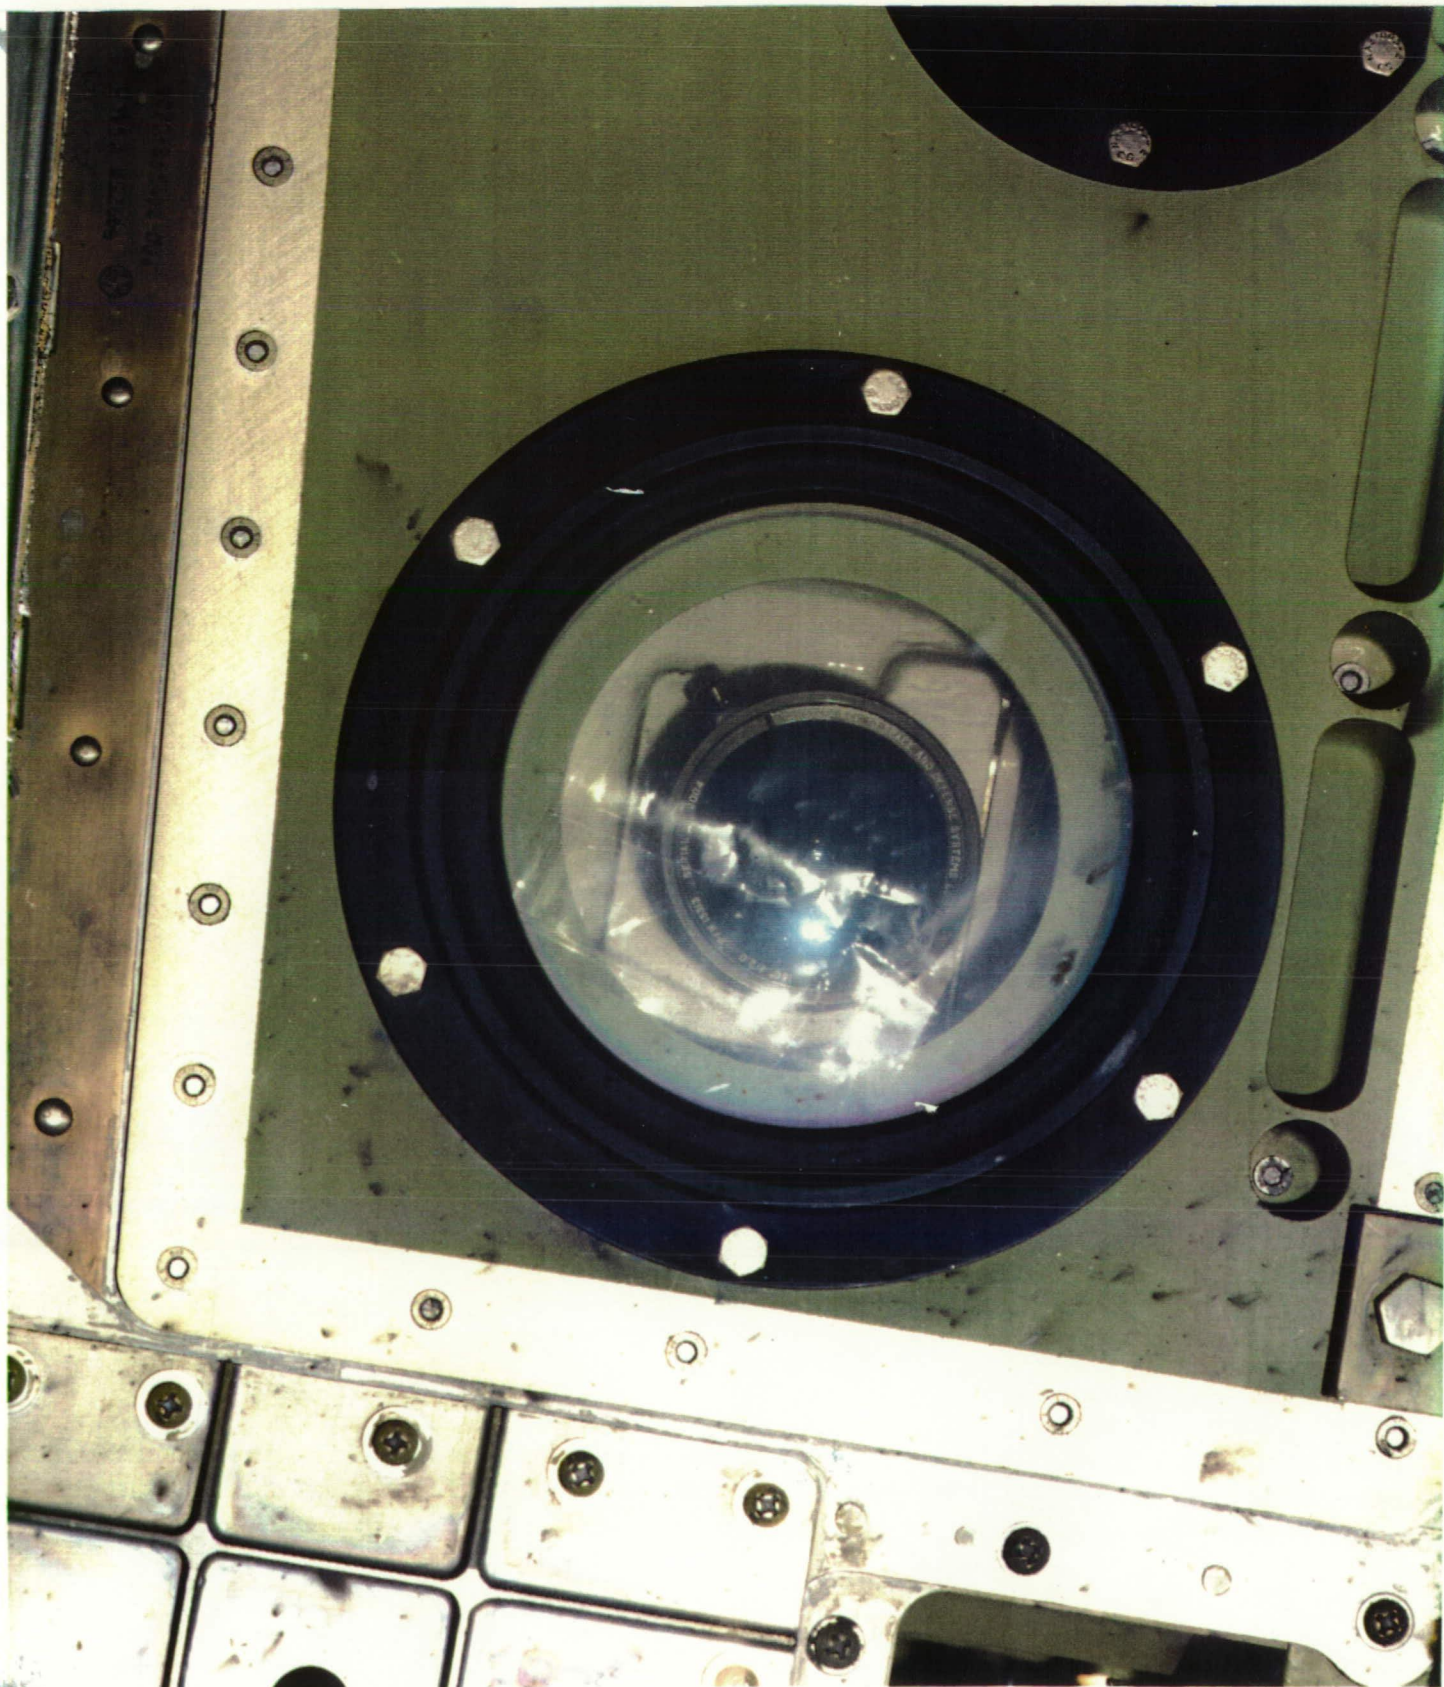
A small plastic bag was found lodged between the 16mm umbilical separation camera and the thermal window pane

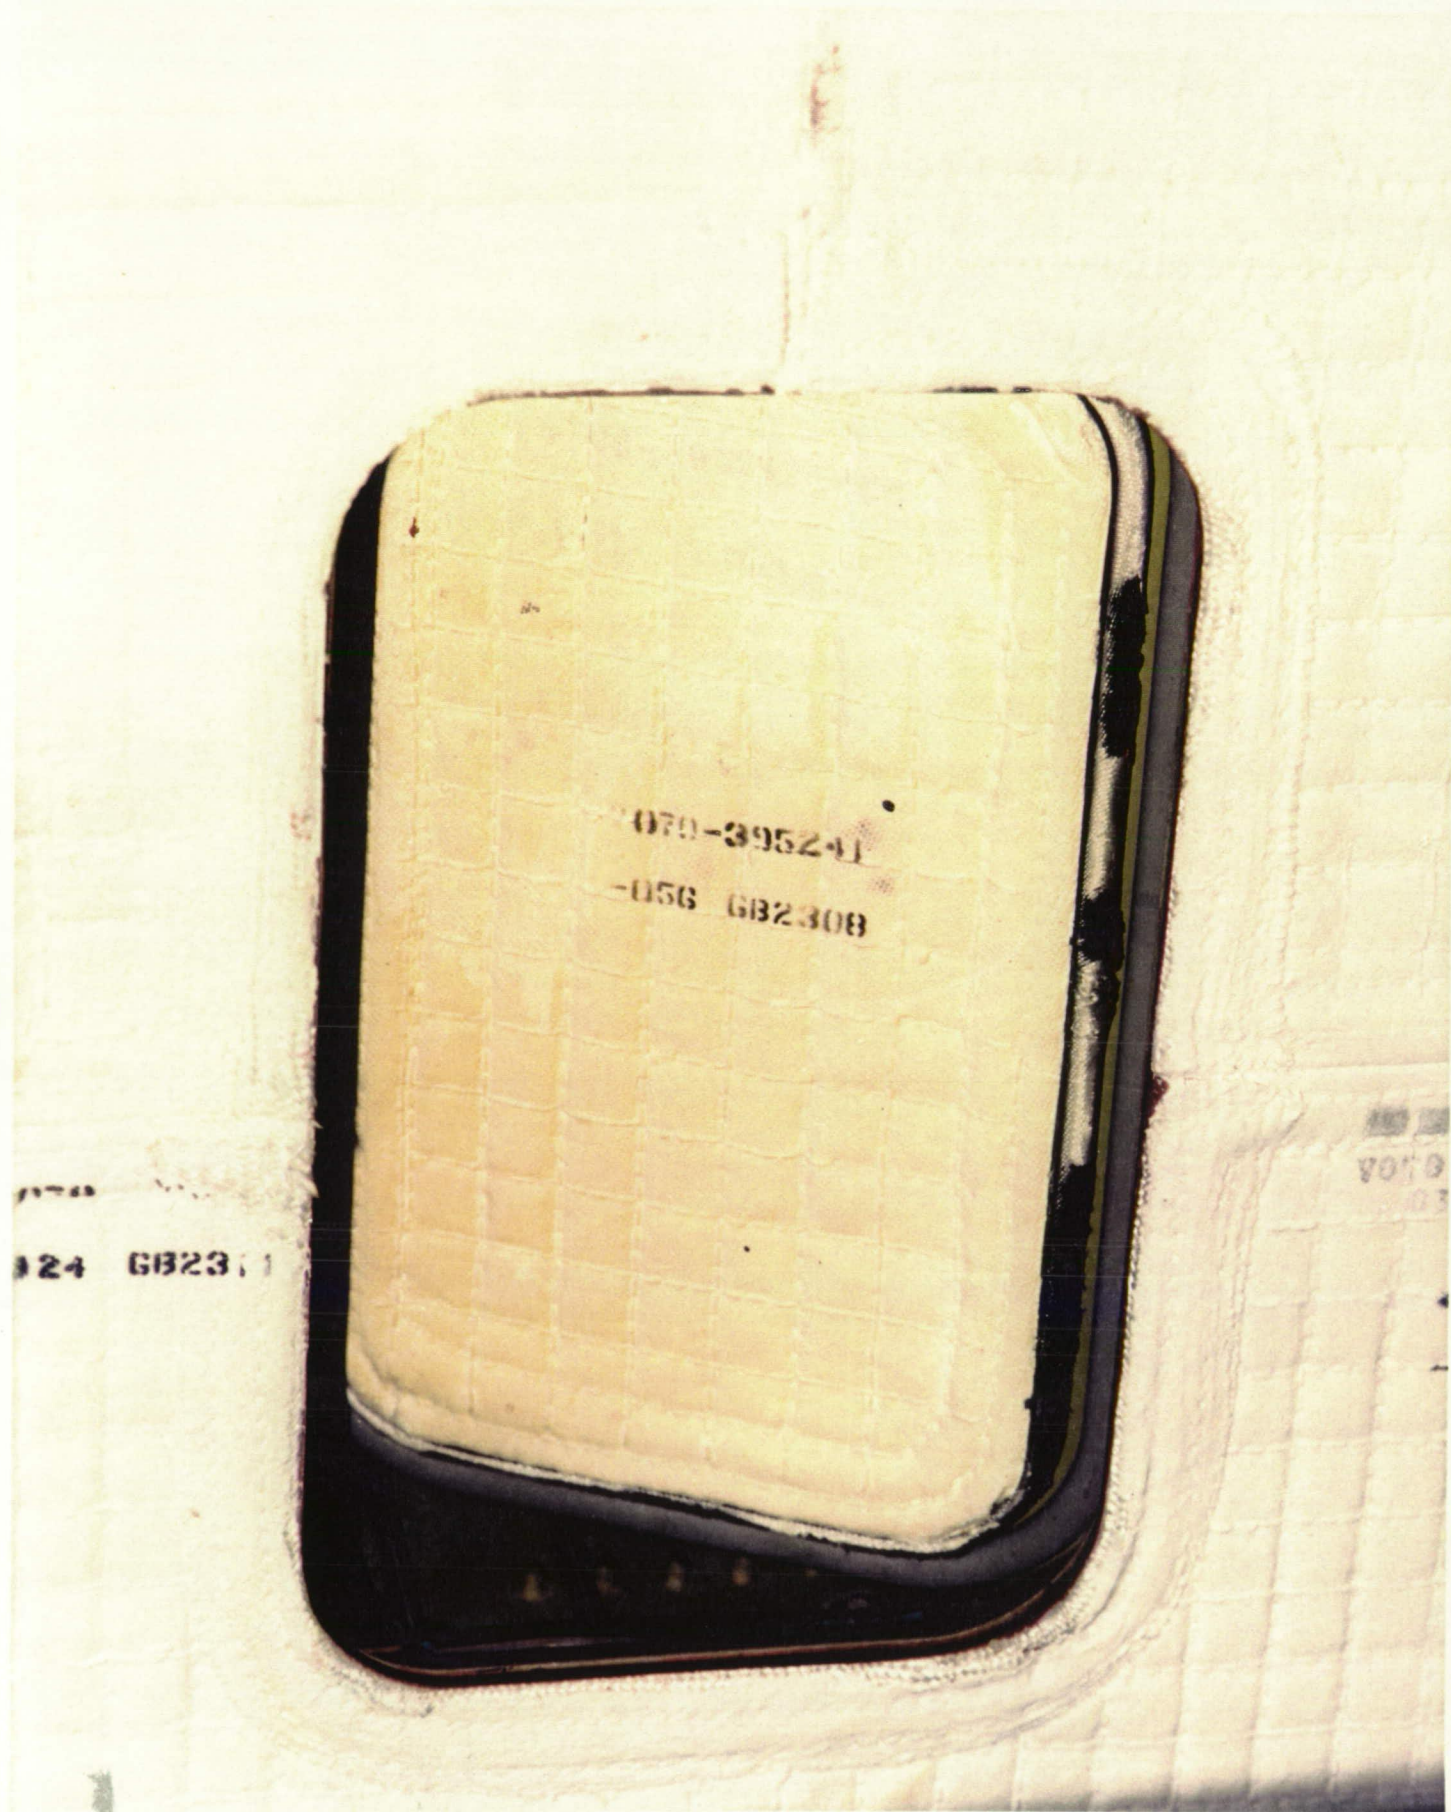
Discoloration on RH vent door #9
